**Flood Control Project Maintenance
Levee Inspections**

Fall 2016 Levee Maintenance Deficiency Summary Report

Reclamation District No. 0070 Meridian

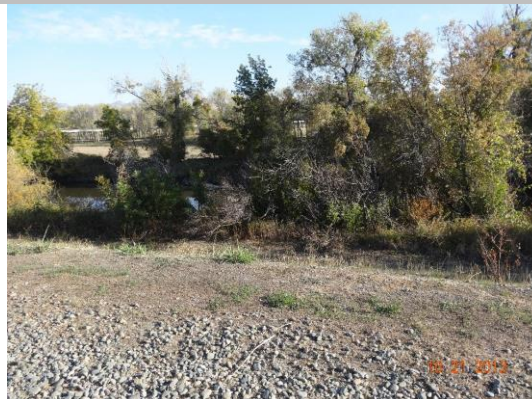
Photo 1 of 2 : UCIP_FA_2016_23463_40622.jpg

View of waterward side--no markers visible.

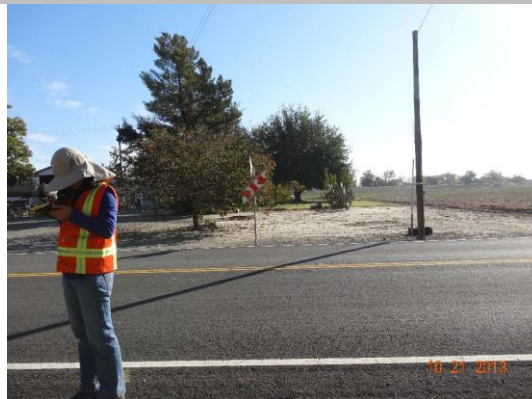
Photo 1 of 2 : UCIP_FA_2016_23384_40249.jpg

LM Start	0.55	Rating **	M	Issue No.	42
LM End	0.55	Issue Type +	En	Location *	WS
Category	Supplemental			GPS Latitude/Longitude	
				Start	End
Item	DWR UCIP Field Study			39.142565 °	39.142565 °
				-121.841600 °	-121.841600 °
DWR ID					
Comment Code					
Inspector Comment					
FS_ID:23384 DS_ID:21415 EP_NO: 15936 Repair Type: Non-Urgent Crossing Status: Indicator Found UCIP Comments: No markers visible on levee slope or levee toe to indicate line crosses levee. Need to contact PG&E to confirm location through levee. Also need to confirm the emergency contact person for this crossing. FIELD_STRUCT_DESC: 8-inch steel pipe through the levee, 2.5 feet below the crown. Gas line markers on the landward side. (Permit No. 15936-2005) FS Date: 10/21/2013

View of markers on the east side of S. Tarke Road.

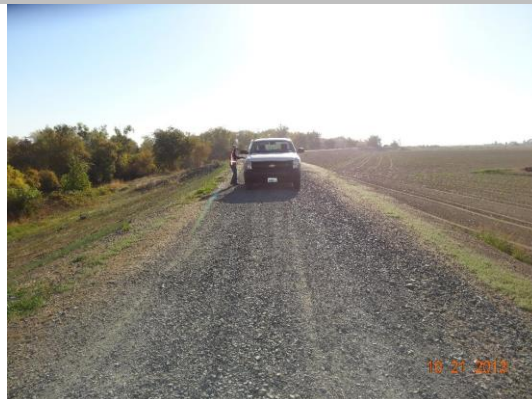
Photo 1 of 2 : UCIP_FA_2016_23503_40784.jpg

FS_ID:23503
DS_ID:21351
EP_NO: 3686
Repair Type: Non-Urgent
Crossing Status: Found
UCIP Comments: Dense vegetation limits the inspector's visibility to identify signs of pipe failure (leaks) along the waterward slope. Recommend removing vegetation along pipe alignment to conduct proper inspection of structure and appurtenances. Unable to find the gate valve on landward side. Walkway on waterward side in bad shape. This crossing is referenced in the USACE Periodic Inspection as item USACE_CESPK_MRD1_2012_p_0300 for 18 inch pipe. Pipe on LS is 10 inch not 18 inch. SEE UCIP DS_ID 21350 for details pertaining to 18 inch pipe.
FIELD_STRUCT_DESC: 10-inch pipe and electrical conduit through the levee, 14.8 and 1.0 feet below the crown, respectively. Gate valve on landward end--not found during 10/21/13 pipe inventory. Pump on pile structure in stream. Walkway to slide gate on waterward end. Rock revetment on waterward slope. Pump and concrete support piers at waterward toe installed under Permit No. 3686 (1963). Service pole with meter and control panel at landward toe.

View of levee crown looking upstream from crossing.

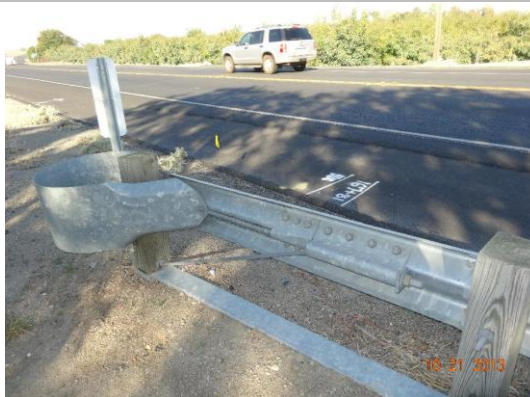
Photo 1 of 2 : UCIP_FA_2016_23467_40643.jpg

FS_ID:23467
DS_ID:21354
EP_NO: 14802
Repair Type: Non-Urgent
Crossing Status: Indicator Found
UCIP Comments: Need to contact owner to determine status of crossing. Need date of last inspection and confirmation that crossing is still in operable condition. Markers found about 159 feet upstream of coordinates at the crossing of the ramp and S. Tarke Road (39.142684, -121.842685).
FIELD_STRUCT_DESC: 4-inch steel gas pipe through the levee, 2.5 feet below the crown. Aluminum pipe marker on landward slope. (Permit No. 14802-1987) Contact emergency information for Pacific Gas & Electric Company 1-800-344-4749? 4742? or 1-916-742-3251.
FS Date: 10/21/2013

Underground Service Alert (USA) flag located at the end of Hwy 20 confirming gas line goes through.

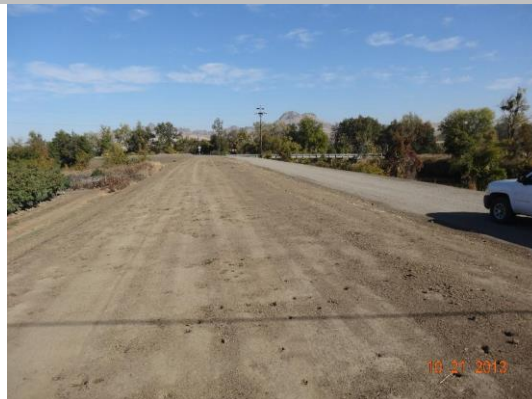
Photo 1 of 2 : UCIP_FA_2016_23526_40942.jpg

Comment Code					
Inspector Comment					
FS_ID:23526 DS_ID:21355 EP_NO: 9961 Repair Type: Non-Urgent Crossing Status: Found UCIP Comments: Dense burrow activity present on both waterward side and landward side. Recommend addressing burrow activity at this location. Also recommend having owner clear vegetation blocking access along walkway. This crossing is referenced in the USACE Periodic Inspection as item USACE_CESPK_MRD1_2012_p_290. FIELD_STRUCT_DESC: 10-inch (not 12-inch as noted in desk study) steel pipe through the levee, 5.4 feet below the crown. Siphon breaker in CM pipe riser on landward slope. 24-inch concrete standpipe at landward toe. Walkway to pump on pile structure in stream. This pipe was retained under ABO No. 9961 (1974). FS Date: 10/21/2013

View of levee crown and waterward berm looking downstream from crossing.

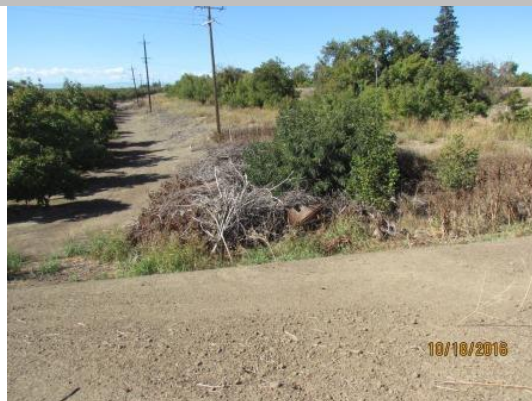
Photo 1 of 1 : FA_2016_RD0070_29_33_20161028_00059.jpg

View of the prunings along the landside toe.

LM Start	0.75	Rating **	M	Issue No.	33
LM End	0.75	Issue Type +	En	Location *	LS
Category	Earthen Levee			GPS Latitude/Longitude	
				Start	End
Item	Encroachments			39.145095 °	39.145095 °
				-121.842865 °	-121.842865 °
DWR ID	DWR_RD0070_01_f_2016_33				
Comment Code					
PR : Prunings					
Inspector Comment					
Remove the prunings from the landside slope.

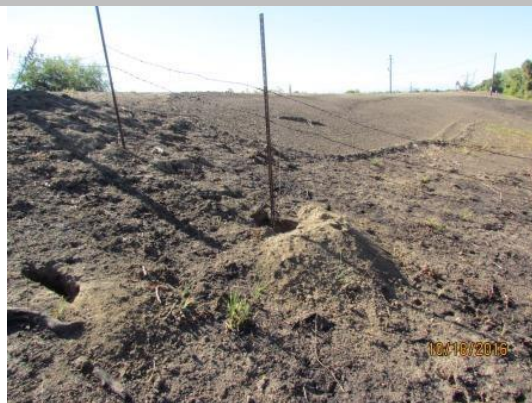
Photo 1 of 1 : FA_2016_RD0070_29_32_20161028_00060.jpg

View of the rodent holes along the waterside slope.

LM Start	1.77	Rating **	M	Issue No.	32
LM End	1.77	Issue Type +	Ma	Location *	LS
Category	Earthen Levee			GPS Latitude/Longitude	
				Start	End
Item	Animal Control			39.151282 °	39.151282 °
				-121.855818 °	-121.855818 °
DWR ID	DWR_RD0070_01_f_2016_32				
Comment Code					
A1 : Exterminate rodents and backfill and compact or grout burrows.					
Inspector Comment

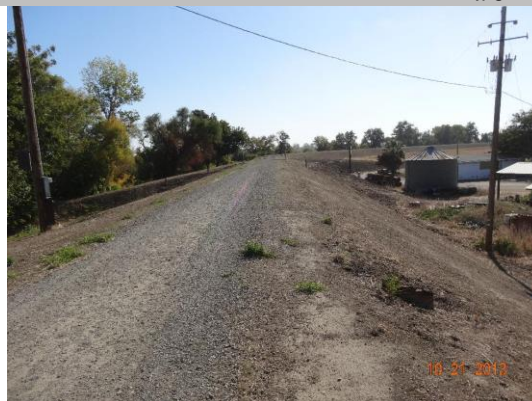
Photo 1 of 2 : UCIP_FA_2016_23508_40821.jpg

FS_ID:23508
DS_ID:21336
EP_NO: N/A
Repair Type: Non-Urgent
Crossing Status: Found
UCIP Comments: Need to find owner to determine if crossing is still in use. If crossing is no longer in use owner will need to coordinate with DWR inspector and CVFPB to remove according to Title 23 requirements. Evidence of high burrow activity on waterward side recommend addressing issue. This crossing is referenced as USACE_CESPK_MRD1_2012_p_0230 in the USACE's PI report for no USACE recommendation letter available -- correction pipe is 12-inch not 16-inch.
FIELD_STRUCT_DESC: 12-inch pipe through the levee, 4.0 feet below the crown. Siphon breaker on the landward slope. Concrete distribution box (7 ft by 9 ft) at landward toe. Service pole on waterward slope. Pump on concrete sump on waterward slope. Overhead power line crosses levee at location. This pipe was retained under ABO No. 9948 (1974) issued to Edward E. and Doris M. Nall. Permit No. 613 issued in May 29, 1934 is for 12 inch pipe issued to Waldo Nall.

View of levee crown looking upstream from crossing.

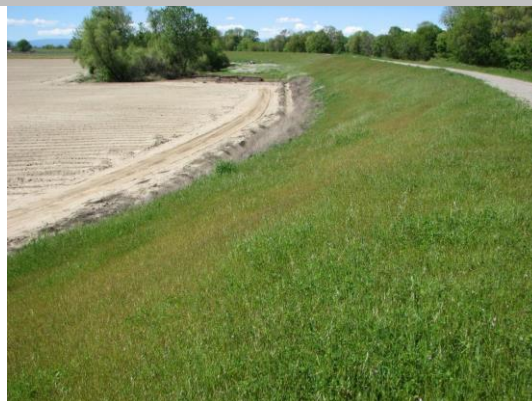
Photo 1 of 1 : FA_2016_RD0070_29_27_20160823_00003.jpg

LM Start	2.74	Rating **	U	Issue No.	27
LM End	2.82	Issue Type +	En	Location *	LS
Category	Earthen Levee			GPS Latitude/Longitude	
				Start	End
Item	Encroachments			39.157741 °	39.158135 °
				-121.871588 °	-121.872979 °
DWR ID	DWR_RD0070_01_s_2016_27				
Comment Code					
DT : Ditch					
Inspector Comment

Concrete ditch at landside toe.

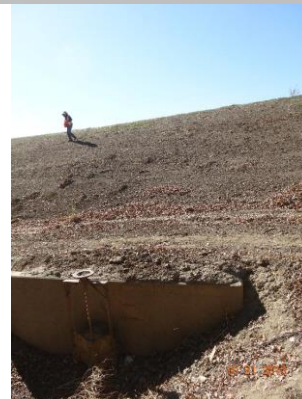
Photo 1 of 2 : UCIP_FA_2016_23510_40837.jpg

Comment Code					
Inspector Comment					
FS_ID:23510 DS_ID:21362 EP_NO: 9944 Repair Type: Non-Urgent Crossing Status: Found UCIP Comments: No pump connection. Need to coordinate with owner to determine status of crossing. If crossing is no longer in use owner will need to contact the CVFPB to comply with Title 23. This crossing is referenced in the USACE Periodic Inspection as item USACE_CESPK_MRD1_2012_p_0183 no USACE recommendation letter available. FIELD_STRUCT_DESC: 18-inch pipe through the levee, 19.5 feet below the crown. Slide gate on waterward end. Pump on waterward side. Concrete distribution box on landward slope. (USACE-1953). This entry matches the Drainage or Irrigation Structure referenced in O&M manual (Station 180+50). This pipe was retained under ABO No. 9944 (1974). FS Date: 10/21/2013

Concrete head wall and screw gate at waterward toe.

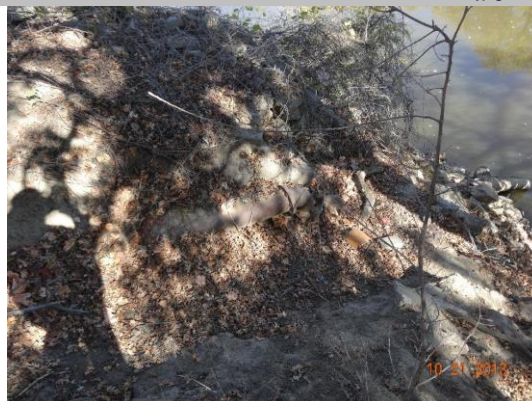
Photo 1 of 2 : UCIP_FA_2016_23516_40873.jpg

Comment Code					
Inspector Comment					
FS_ID:23516 DS_ID:21339 EP_NO: 9951 Repair Type: Non-Urgent Crossing Status: Found UCIP Comments: Need to coordinate with owner to determine status of crossing. If crossing is no longer in use owner will need to contact the CVFPB to comply with Title 23. This crossing is referenced in the USACE Periodic Inspection as item USACE_CESPK_MRD1_2012_p_0144. FIELD_STRUCT_DESC: 10-inch steel pipe through the levee, 16.3 feet below the crown. Pipe crosses levee at a 45 degree angle. Siphon breaker in CM pipe riser on landward slope. Gate valve on waterward end. Discharges into concrete discharge box. This pipe was retained under ABO No. 9951 (1974). FS Date: 10/21/2013

View of pipe located on waterward side.

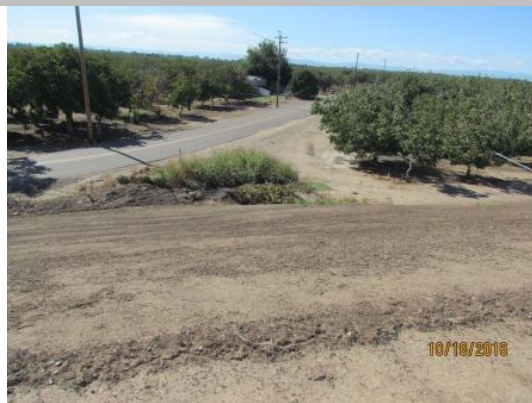
Photo 1 of 1 : FA_2016_RD0070_29_30_20161028_00062.jpg

View of the prunings along the landside toe.

LM Start	4.65	Rating **	M	Issue No.	30
LM End	4.65	Issue Type +	En	Location *	LS
Category	Earthen Levee			GPS Latitude/Longitude	
				Start	End
Item	Encroachments			39.168110 °	39.168110 °
				-121.899910 °	-121.899910 °
DWR ID	DWR_RD0070_01_f_2016_30				
Comment Code					
PR : Prunings					
Inspector Comment					
Remove the prunings from the landside slope.

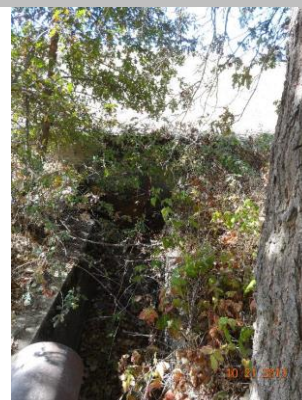
Photo 2 of 2 : UCIP_FA_2016_23517_40877.jpg

View of pipe located on waterward side.

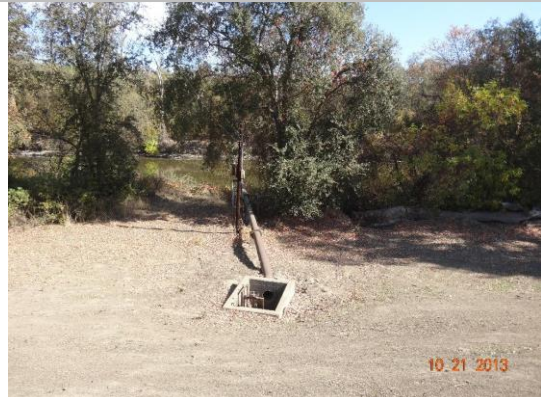
Photo 1 of 2 : UCIP_FA_2016_23518_40886.jpg

View of waterward side--pipe and concrete distribution box.

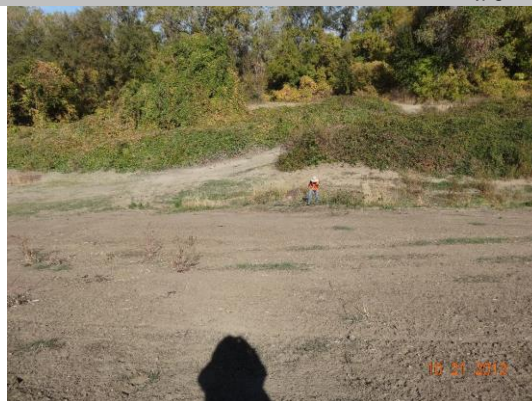
Photo 2 of 2 : UCIP_FA_2016_46422_40914.jpg

Comment Code						
Inspector Comment						
FS_ID:46422 DS_ID:21341 EP_NO: 9960 Repair Type: Non-Urgent Crossing Status: Found UCIP Comments: 07/28/2015 Pipe appears still appears abandoned. Priority was downgraded from Urgent to Non-Urgent due to the inactivity. Need to contact owner to confirm status and future use. If crossing is no longer in use owner will need to coordinate with DWR inspector and CVFPB to remove according to Title 23 requirements.10/21/2013 Hole present on pipe on waterward side. This crossing was determined urgent due to hole on pipe-no signs leaks present on waterward or landward slopes. Unable to find if crossing is being used. Need to contact owner to determine crossing is still in use. If crossing is no longer in use owner will need to coordinate with DWR inspector and CVFPB to remove according to Title 23 requirements. Unable to determine if crossing is in use. This crossing is referenced in the USACE Periodic Inspection as item USACE_CESPK_MRD1_2012_p_0069. FIELD_STRUCT_DESC: 12-inch steel pipe through the levee, 6.2 feet below the crown. Siphon breaker in CM pipe riser on the landward slope. Service pole on the landward shoulder. Concrete distribution box at the landward toe. (USACE-1953). This entry matches the Drainage or Irrigation Structure referenced in O&M manual (Station 332+72). This pipe was retained under ABO No. 9960 (1974). FS Date: 7/28/2015 3:30:00 PM

View of waterward side.

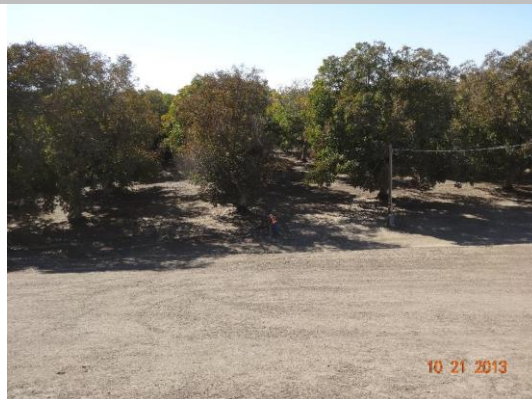
Photo 1 of 2 : UCIP_FA_2016_49188_40922.jpg

View of landward side.

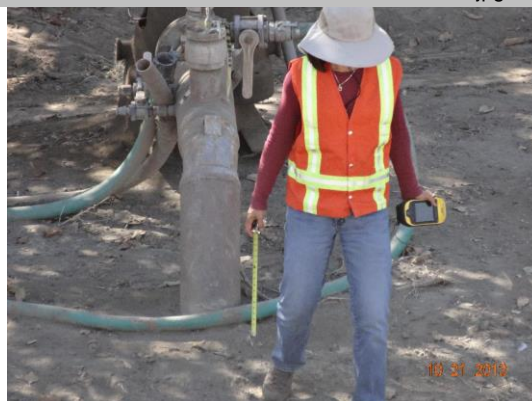
Photo 2 of 2 : UCIP_FA_2016_49188_40921.jpg

Pump system and pipe on landward side.

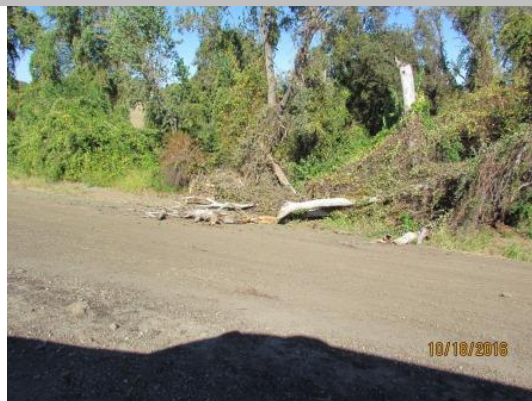
Photo 1 of 1 : FA_2016_RD0070_29_31_20161028_00063.jpg

View of a fallen tree along the waterside toe.

LM Start	7.16	Rating **	M	Issue No.	31
LM End	7.16	Issue Type +	Ma	Location *	WS
Category	Earthen Levee			GPS Latitude/Longitude	
				Start	End
Item	Encroachments			39.196157 °	39.196157 °
				-121.922688 °	-121.922688 °
DWR ID	DWR_RD0070_01_f_2016_31				
Comment Code					
TR : Tree or limb					
Inspector Comment					
Remove the fallen tree.

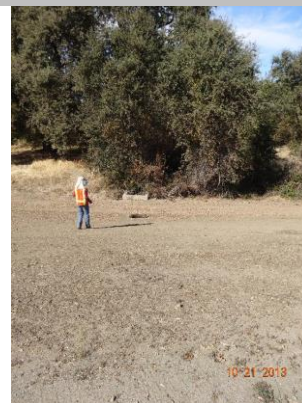
Photo 1 of 2 : UCIP_FA_2016_23529_40964.jpg

Comment Code					
Inspector Comment					
FS_ID:23529 DS_ID:21345 EP_NO: 9942 Repair Type: Non-Urgent Crossing Status: Found UCIP Comments: Dense vegetation limits the inspector's visibility to identify signs of pipe failure (leaks) along the slope. Recommend removing vegetation along pipe alignment to conduct proper inspection of structure and appurtenances. This crossing is referenced in the USACE Periodic Inspection as item USACE_CESPK_MRD1_2012_p_0005. FIELD_STRUCT_DESC: 24-inch CM pipe through the levee, 16.5 feet below the crown. Slide gate in CM pipe rise on waterward slope. Incline pump on waterward side. Discharges to concrete box at the landward toe. Service pole on landward side. (USACE-1953). This entry matches the Drainage or Irrigation Structure referenced in O&M manual (Station 330+00). This pipe was retained under ABO No. 9942 (1974). FS Date: 10/21/2013

View of waterward slope.

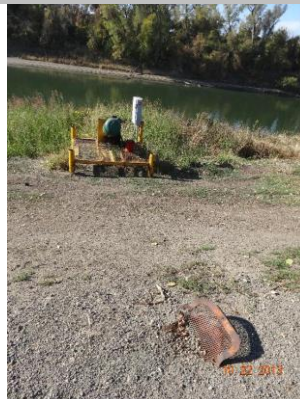
Photo 1 of 2 : UCIP_FA_2016_23952_42061.jpg

View of waterward side--siphon breaker housing unit, pipe daylight, pump, and platform.

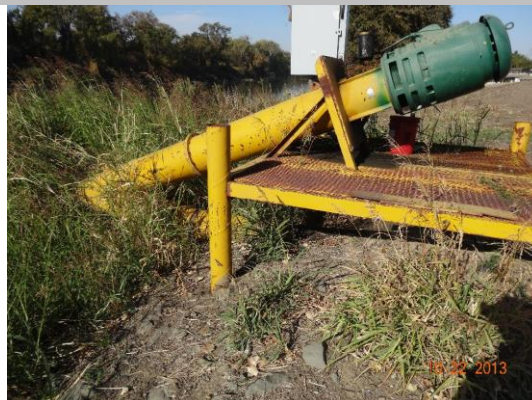
Photo 2 of 2 : UCIP_FA_2016_23952_42060.jpg

View of pump on waterward side.

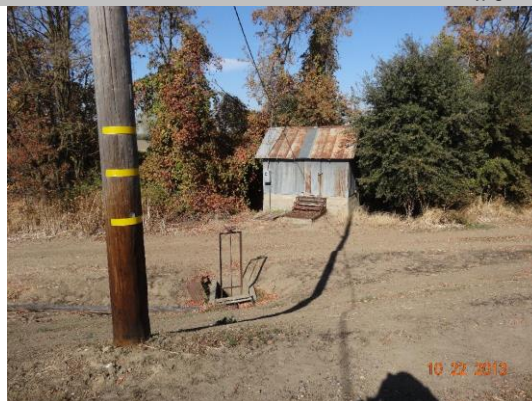
Photo 1 of 2 : UCIP_FA_2016_42923_42036.jpg

View of waterward side--appurtenances present pump house, concrete distribution box, screw gate, and power pole.

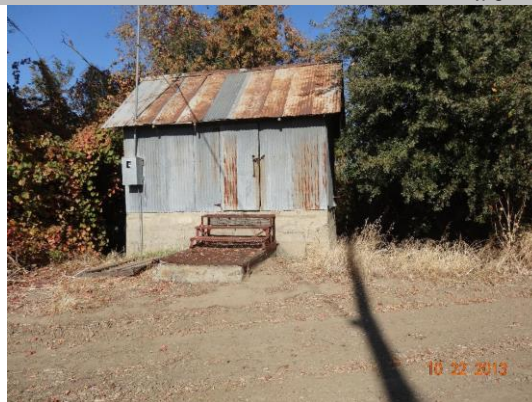
Photo 2 of 2 : UCIP_FA_2016_42923_42041.jpg

Pump station on waterward side.

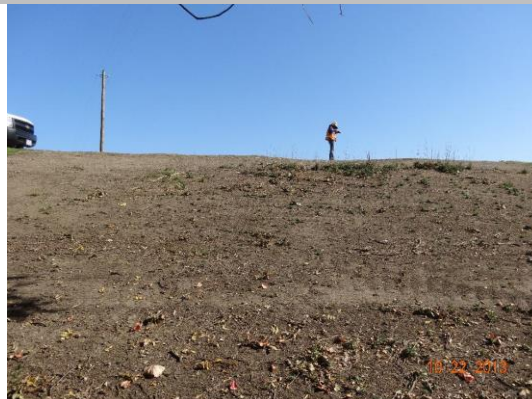
Photo 1 of 2 : UCIP_FA_2016_23885_41814.jpg

View of waterward slope.

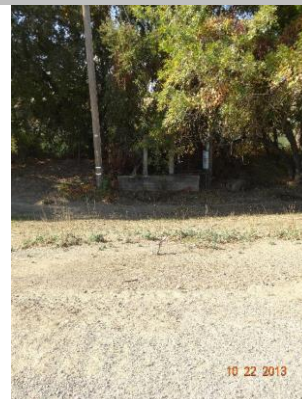
Photo 2 of 2 : UCIP_FA_2016_23885_41817.jpg

Overview of waterward slope.

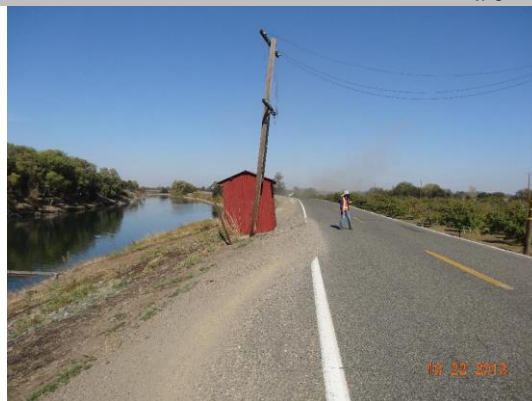
Photo 1 of 2 : UCIP_FA_2016_23888_41819.jpg

Comment Code					
Inspector Comment					
FS_ID:23888					
DS_ID:21366					
EP_NO: 9996					
Repair Type: Non-Urgent					
Crossing Status: Found					
UCIP Comments: Need inside photo of the concrete distribution box located at the landward toe. Debris found on waterward slope (conduit running parallel to levee). This crossing is referenced in the USACE Periodic Inspection as item USACE_CESPK_MRD2_2012_p_0124.					
FIELD_STRUCT_DESC: 12-inch steel pipe through the levee, 24.0 feet below the crown. Gate valve in concrete "U" headwall on waterward slope. Switch house and pump on waterward shoulder. Discharge box at landward toe. This pipe was retained under ABO No. 9996 (1974).					
FS Date: 10/22/2013

View of levee crown and waterward side.

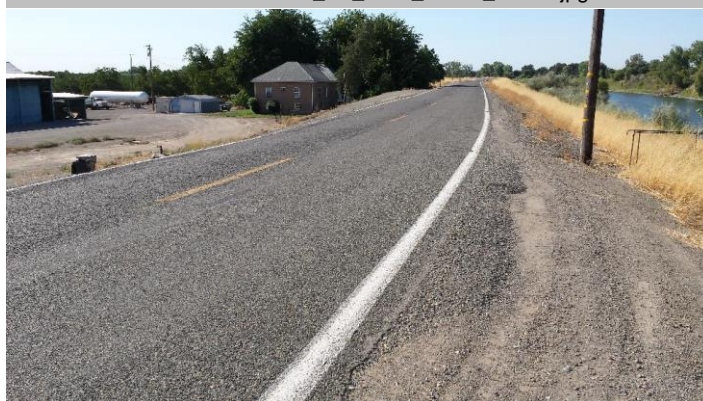
Photo 1 of 2 : UCIP_FA_2016_50006_74608.jpg

View of county road where pipe crosses.

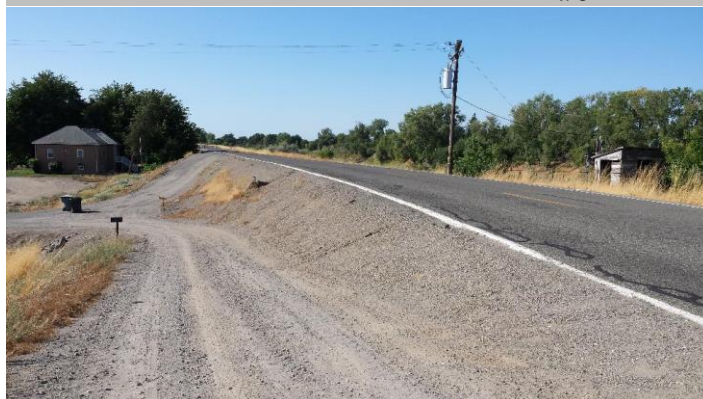
Photo 2 of 2 : UCIP_FA_2016_50006_74603.jpg

View of LS and county road (N. Meridian Road).

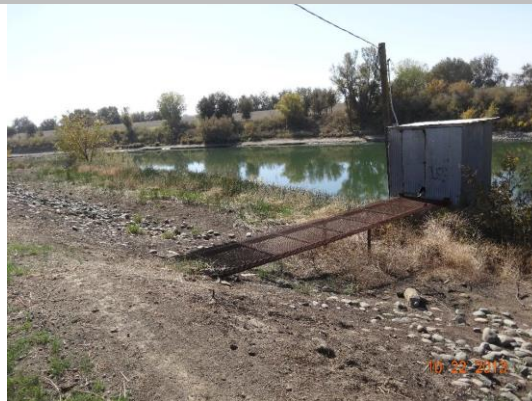
Photo 1 of 2 : UCIP_FA_2016_23891_41835.jpg

Comment Code					
Inspector Comment					
FS_ID:23891 DS_ID:21368 EP_NO: 9969 Repair Type: Non-Urgent Crossing Status: Found UCIP Comments: Landward slope too steep--need photo of the inside of concrete distribution box. Dense vegetation limits the inspector's visibility to identify signs of pipe failure (leaks) along the waterward slope. Recommend removing vegetation along pipe alignment to conduct proper inspection of structure and appurtenances. This crossing is referenced in the USACE Periodic Inspection as item USACE_CESPK_MRD2_2012_p_0158. FIELD_STRUCT_DESC: 20-inch (not 24-inch as mentioned in desk study) steel pipe through the levee, 27.0 feet below the crown. CM cutoff wall around pipe at center of levee. Pump and gate valve in pump house on the waterward slope. Discharges into concrete box at the landward toe. (USACE-1953). This entry matches the Drainage or Irrigation Structure referenced in O&M manual (Station 455+39). This pipe was retained under ABO No. 9969 (1974). FS Date: 10/22/2013

View of waterward side.

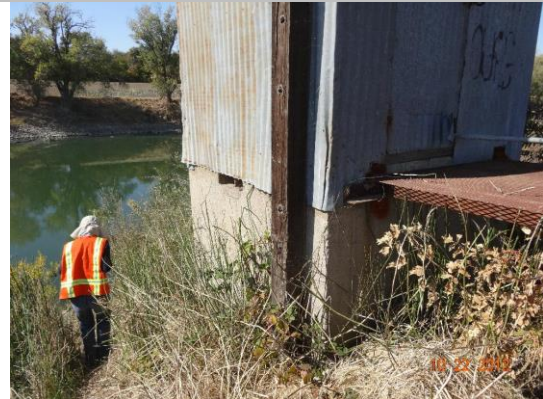
Photo 2 of 2 : UCIP_FA_2016_23891_41833.jpg

Comment Code						
Inspector Comment						
FS_ID:23891 DS_ID:21368 EP_NO: 9969 Repair Type: Non-Urgent Crossing Status: Found UCIP Comments: Landward slope too steep--need photo of the inside of concrete distribution box. Dense vegetation limits the inspector's visibility to identify signs of pipe failure (leaks) along the waterward slope. Recommend removing vegetation along pipe alignment to conduct proper inspection of structure and appurtenances. This crossing is referenced in the USACE Periodic Inspection as item USACE_CESPK_MRD2_2012_p_0158. FIELD_STRUCT_DESC: 20-inch (not 24-inch as mentioned in desk study) steel pipe through the levee, 27.0 feet below the crown. CM cutoff wall around pipe at center of levee. Pump and gate valve in pump house on the waterward slope. Discharges into concrete box at the landward toe. (USACE-1953). This entry matches the Drainage or Irrigation Structure referenced in O&M manual (Station 455+39). This pipe was retained under ABO No. 9969 (1974). FS Date: 10/22/2013

Pump station located on waterward side.

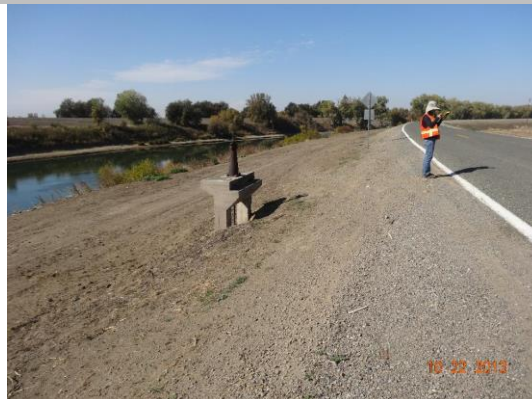
Photo 1 of 2 : UCIP_FA_2016_23892_41839.jpg

FS_ID:23892
DS_ID:21369
EP_NO: N/A
Repair Type: Non-Urgent
Crossing Status: Found
UCIP Comments: If crossing is no longer used by owner, the owner will need to coordinate with DWR Inspector and CVFPB to remove crossing according to Title 23 requirements. Dense vegetation limits the inspector's visibility to identify signs of pipe failure (leaks) along the slope. Recommend removing vegetation along pipe alignment to conduct proper inspection of structure and appurtenances. This crossing is referenced in the USACE Periodic Inspection as item USACE_CESPK_MRD1_2012_p_0167.
FIELD_STRUCT_DESC: *ABANDONED* 24-inch CM pipe through the levee, 21.0 feet below the crown. Slide gate on waterward end. (Cat. IVA)
FS Date: 10/22/2013

View of waterward side.

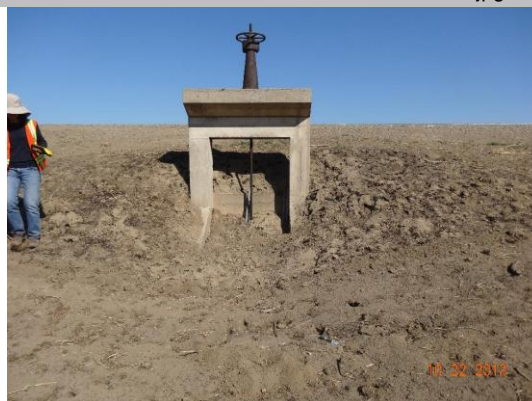
Photo 2 of 2 : UCIP_FA_2016_23892_41841.jpg

Buried screw gate located on waterward shoulder.

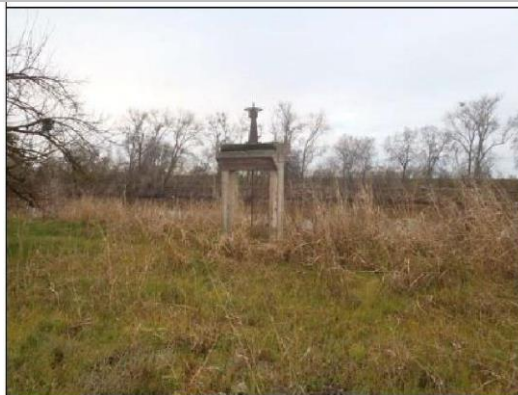
Photo 1 of 2 : UCIP_FA_2016_24115_42495.jpg

LM Start	3.35	Rating **	M	Issue No.	91
LM End	3.35	Issue Type +	En	Location *	LS
Category	Supplemental			GPS Latitude/Longitude	
				Start	End
Item	DWR UCIP Field Study			39.156068 °	39.156068 °
				-121.923453 °	-121.923453 °
DWR ID					
Comment Code					
Inspector Comment					
FS_ID:24115 DS_ID:21370 EP_NO: N/A Repair Type: Non-Urgent Crossing Status: Found UCIP Comments: No connection present--need to contact owner to determine if owner plans to use. If crossing is no longer in use owner will need to coordinate with DWR inspector and CVFPB to remove according to Title 23 requirements. This crossing is referenced in the USACE Periodic Inspection as USACE_CESPK_MRD2_2012_p_0197. FIELD_STRUCT_DESC: *ABANDONED* 24-inch pipe through the levee, 18.5 feet below the crown. Slide gate on concrete gate structure on berm. FS Date: 10/22/2013

View of waterward side--photo is from USACE PI Report draft final issue USACE_CESPK_MRD2_2012_p_0197.

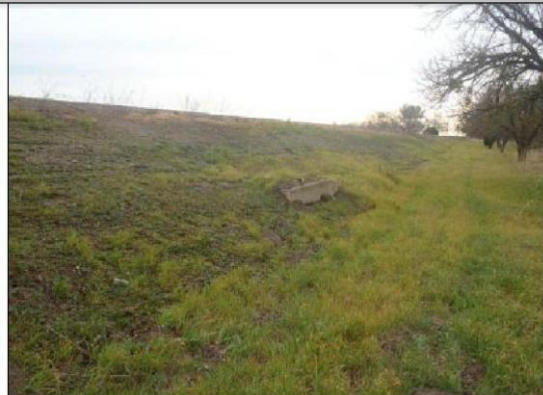
Photo 2 of 2 : UCIP_FA_2016_24115_42496.jpg

View of landward side--photo is from USACE PI Report draft final issue USACE_CESPK_MRD2_2012_p_0197.

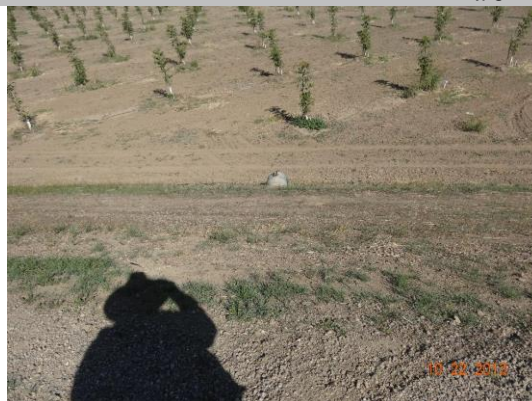
Photo 1 of 2 : UCIP_FA_2016_24117_42502.jpg

LM Start	3.40	Rating **	M	Issue No.	92
LM End	3.40	Issue Type +	En	Location *	LS
Category	Supplemental			GPS Latitude/Longitude	
				Start	End
Item	DWR UCIP Field Study			39.155648 °	39.155648 °
				-121.922823 °	-121.922823 °
DWR ID					
Comment Code					
Inspector Comment					
FS_ID:24117					
DS_ID:21371					
EP_NO: N/A					
Repair Type: Non-Urgent					
Crossing Status: Found					
UCIP Comments: No connection present--need to contact owner to determine if owner plans to use. If crossing is no longer in use owner will need to coordinate with DWR inspector and CVFPB to remove according to Title 23 requirements. This crossing is referenced in the USACE Periodic Inspection as USACE_CESPK_MRD2_2012_p_0197.					
FIELD_STRUCT_DESC: *ABANDONED* 24-inch pipe through the levee, 18.5 feet below the crown. Slide gate on concrete gate structure on berm.					
FS Date: 10/22/2013

View of pipe on landward side.

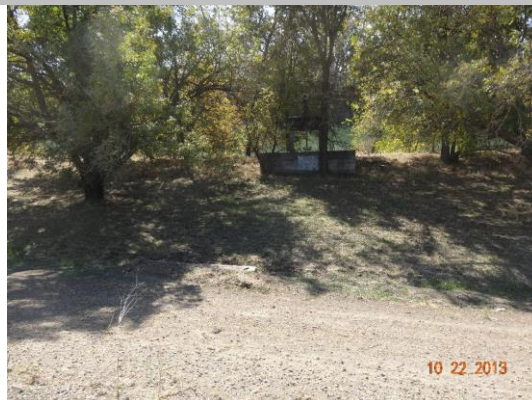
Photo 2 of 2 : UCIP_FA_2016_24117_42501.jpg

View of concrete headwall and screw gate on waterward side.

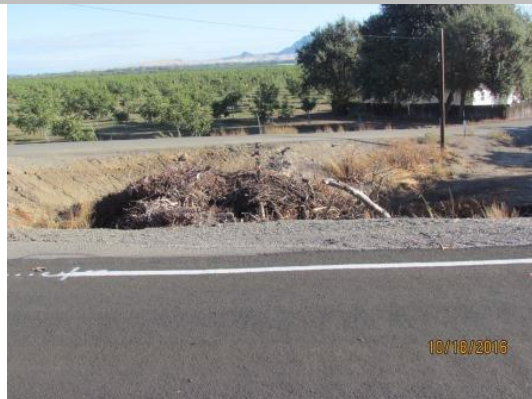
Photo 1 of 1 : FA_2016_RD0070_30_50_20161028_00108.jpg

LM Start	3.57	Rating **	M	Issue No.	50
LM End	3.57	Issue Type +	En	Location *	LS
Category	Earthen Levee			GPS Latitude/Longitude	
				Start	End
Item	Encroachments			39.154059 °	39.154059 °
				-121.920220 °	-121.920220 °
DWR ID	DWR_RD0070_02_f_2016_50				
Comment Code					
PR : Prunings					
Inspector Comment					
Remove the prunings from the landside slope.

View of the prunings along the landside toe.

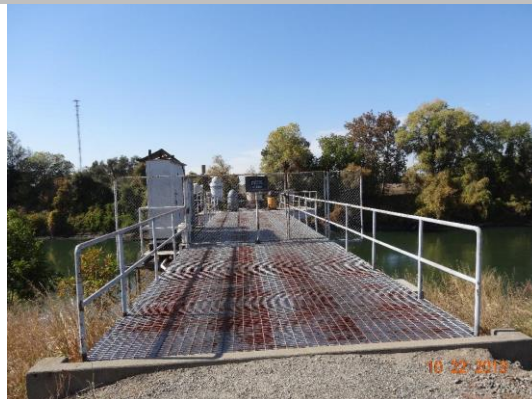
Photo 1 of 2 : UCIP_FA_2016_47030_42563.jpg

FS_ID:47030
DS_ID:21429
EP_NO: N/A
Repair Type: Non-Urgent
Crossing Status: Found
UCIP Comments: Pump is to be demolished will all pipes removed. Will need to update record. This crossing is referenced in the USACE Periodic Inspection as item USACE_CESPK_MRD2_2012_p_0235.
FIELD_STRUCT_DESC: [Farms Water Company Pumping Plant No. 2]
3 of 4: 42-inch steel pipe and 2-inch PVC electrical conduit through the levee, 24.0 and 3.0 feet below the crown, respectively. Pipe is concrete encased through the levee. Two concrete cutoff walls, one at each shoulder. Slide gate in surge box on the waterward side. Concrete pump pit on the waterward slope. Three pumps on structure on the waterward side. Walkway to the pumps with electrical control box. Concrete headwall on landward side. Discharges into concrete lined irrigation ditch on the landward side. Debris deflectors in river. Power poles on landward side. (Permit No. 13380-2002). Pumping plant is to be demolished with all pipes removed and replaced with single 72-inch gravity feed pipe under Permit No. 18762 (2013).

View of walkway and pump station on waterward side.

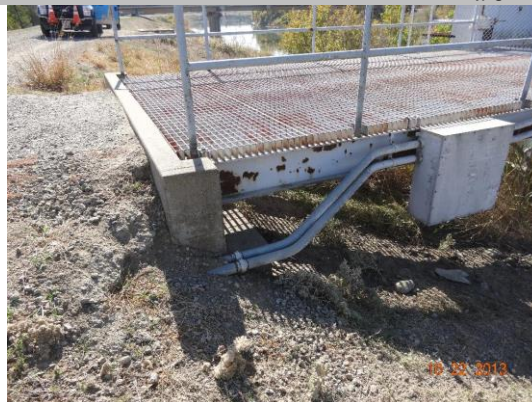
Photo 2 of 2 : UCIP_FA_2016_47030_42567.jpg

View of conduit pipes through levee.

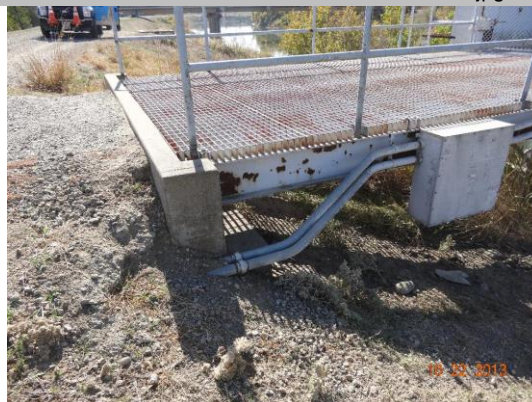
Photo 2 of 2 : UCIP_FA_2016_47032_42080.jpg

FS_ID:47032
DS_ID:21373
EP_NO: N/A
Repair Type: Non-Urgent
Crossing Status: Indicator Found
UCIP Comments: Unable to confirm 54-inch pipe only found 42-inch pipe. Pump station is to be removed. Need to update record once crossing has been modified. This crossing is referenced in the USACE Periodic Inspection as item USACE_CESPK_MRD2_2012_p_0235.
FIELD_STRUCT_DESC: [Farms Water Company Pumping Plant No. 1]
4 of 4: 54-inch steel pipe through the levee, 24.0 feet below the crown. Pipe is concrete encased through the levee. Two concrete cutoff walls, one at each shoulder. Slide gate in surge box on the waterward side. Concrete pump pit on the waterward slope. Three pumps on structure on the waterward side. Walkway to the pumps. Concrete headwall on landward side. Discharges into concrete lined irrigation ditch on the landward side. Debris deflectors in river. (Permit No. 4525-1965). Pumping plant is to be demolished with all pipes removed and replaced with single 72-inch gravity feed pipe under Permit No. 18762 (2013).

View of conduit pipes through levee.

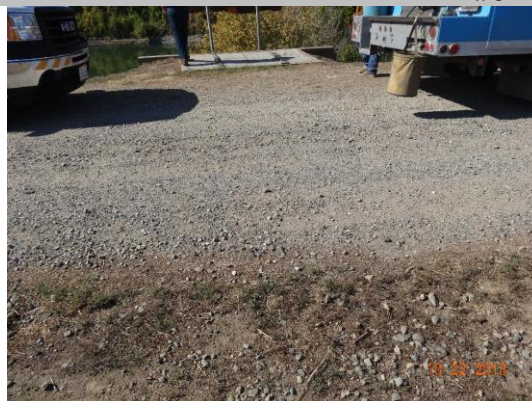
Photo 1 of 2 : UCIP_FA_2016_24165_42573.jpg

FS_ID:24165
DS_ID:21374
EP_NO: 767
Repair Type: Non-Urgent
Crossing Status: Found
UCIP Comments: Need to contact owner to determine if crossing is still active and to determine last inspection date. Will need copy of letter showing crossings passed inspection. This crossing is referenced in the USACE Periodic Inspection as item
USACE_CESPK_MRD2_2012_p_0237.
FIELD_STRUCT_DESC: 3.0-inch steel gas pipe (not 3.5-inch as mentioned in desk study) through the levee, 3.0 feet below the crown. Concrete inspection well (8x10x1 foot) with metal cover on waterward shoulder. Painted aluminum marker on waterward side. Rock revetment on waterward slope. (Permit No. 767-1938) Contact information provided on marker 916-742-7344 and for emergencies call 916-742-3251.
FS Date: 10/22/2013

View of levee crown.

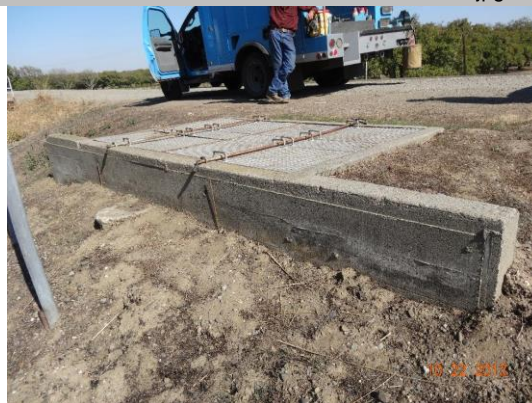
Photo 2 of 2 : UCIP_FA_2016_24165_42575.jpg

Concrete headwall on waterward side.

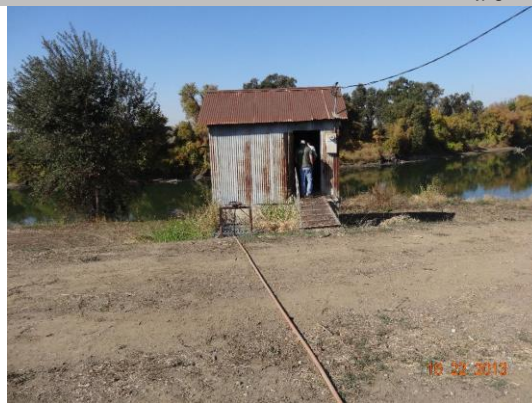
Photo 1 of 2 : UCIP_FA_2016_23962_42099.jpg

Comment Code					
Inspector Comment					
FS_ID:23962 DS_ID:21379 EP_NO: 9998 Repair Type: Non-Urgent Crossing Status: Found UCIP Comments: Unable to confirm if crossing corresponds to permit 9998. Pipe size is different then the pipe size listed in the desk study. Unable to confirm if structure on landward side is a pump house. Need to coordinate with owner to obtain permit record for crossing. Need to verify status of crossing. Permit authorized 24 inch pipe. Pipe through levee is 30 inches. Unable to find stand pipe in field. Dense vegetation limits the inspector's visibility to identify signs of pipe failure (leaks) along the slope. Recommend removing vegetation along pipe alignment to conduct proper inspection of structure and appurtenances. This crossing is referenced in the USACE Periodic Inspection as item USACE_CESPK_MRD2_2012_p_0264. FIELD_STRUCT_DESC: 30-inch (not 24-inch as indicated in desk study) CM pipe through the levee, 15.5 feet below the crown. Slide gate in concrete distribution box at landward toe. Pump in pumphouse at landward side. Service pole and ramp on waterward slope. Concrete box with air vents at waterward end. (USACE-1953). This entry matches the Drainage or Irrigation Structure referenced in O&M manual (Station 516+06). This pipe was retained under ABO No. 9998 (1974). 18-inch PVC pipe sleeved through the 24-inch pipe under Permit No. 16228 (1994). Annular gap grouted. FS Date: 10/22/2013

View of pump house located on waterward side.

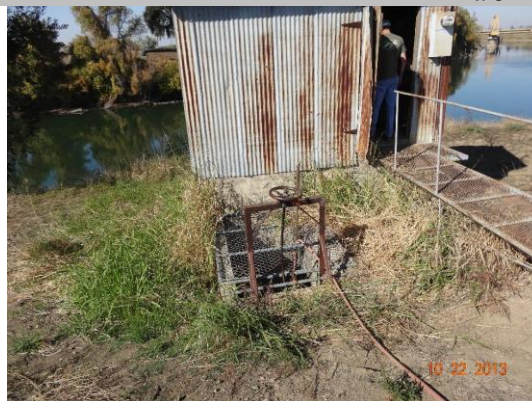
Photo 2 of 2 : UCIP_FA_2016_23962_42104.jpg

Comment Code						
Inspector Comment						
FS_ID:23962 DS_ID:21379 EP_NO: 9998 Repair Type: Non-Urgent Crossing Status: Found UCIP Comments: Unable to confirm if crossing corresponds to permit 9998. Pipe size is different then the pipe size listed in the desk study. Unable to confirm if structure on landward side is a pump house. Need to coordinate with owner to obtain permit record for crossing. Need to verify status of crossing. Permit authorized 24 inch pipe. Pipe through levee is 30 inches. Unable to find stand pipe in field. Dense vegetation limits the inspector's visibility to identify signs of pipe failure (leaks) along the slope. Recommend removing vegetation along pipe alignment to conduct proper inspection of structure and appurtenances. This crossing is referenced in the USACE Periodic Inspection as item USACE_CESPK_MRD2_2012_p_0264. FIELD_STRUCT_DESC: 30-inch (not 24-inch as indicated in desk study) CM pipe through the levee, 15.5 feet below the crown. Slide gate in concrete distribution box at landward toe. Pump in pumphouse at landward side. Service pole and ramp on waterward slope. Concrete box with air vents at waterward end. (USACE-1953). This entry matches the Drainage or Irrigation Structure referenced in O&M manual (Station 516+06). This pipe was retained under ABO No. 9998 (1974). 18-inch PVC pipe sleeved through the 24-inch pipe under Permit No. 16228 (1994). Annular gap grouted. FS Date: 10/22/2013

Positive closure device located at the waterward side inside concrete distribution box.

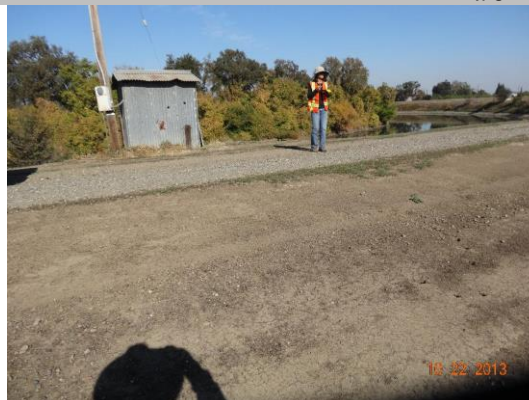
Photo 2 of 2 : UCIP_FA_2016_24166_42580.jpg

Comment Code					
Inspector Comment					
FS_ID:24166 DS_ID:21380 EP_NO: 9970 Repair Type: Non-Urgent Crossing Status: Found UCIP Comments: Need to coordinate with owner to determine status of crossing. No pump is located inside the pump house located on waterward side. If crossing is no longer in use owner will need to contact the CVFPB to comply with Title 23. Dense vegetation limits the inspector's visibility to identify signs of pipe failure (leaks) along the slope. Recommend removing vegetation along pipe alignment to conduct proper inspection of structure and appurtenances. This crossing is referenced in the USACE Periodic Inspection as item USACE_CESPK_MRD2_2012_p_0274. FIELD_STRUCT_DESC: 10-inch steel pipe through the levee, 4.8 feet below the crown. CM cutoff wall around pipe at center of levee. Siphon breaker on landward slope--not found. Pump in pump house on waterward shoulder. Shut-off valve on landward side. Concrete discharge box at landward toe. (USACE-1953). This entry matches the Drainage or Irrigation Structure referenced in O&M manual (Station 526+71). This pipe was retained under ABO No. 9970 (1974). FS Date: 10/22/2013

View of levee crown and pump house photo taken from landward side.

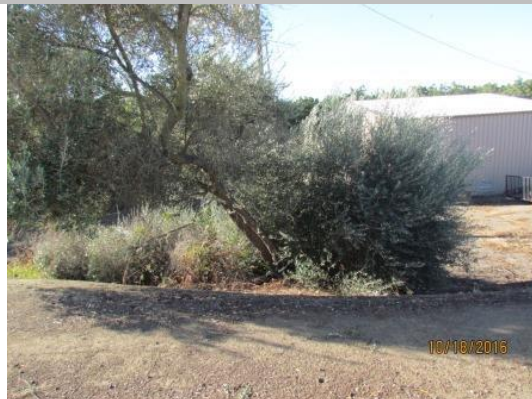
Photo 1 of 1 : FA_2016_RD0070_30_54_20161028_00110.jpg

LM Start	4.95	Rating **	M	Issue No.	54
LM End	4.95	Issue Type +	Ma	Location *	LS
Category	Earthen Levee			GPS Latitude/Longitude	
				Start	End
Item	Trim / Thin Trees			39.142016 °	39.142016 °
				-121.926214 °	-121.926214 °
DWR ID	DWR_RD0070_02_f_2016_54				
Comment Code					
T1 : Trim trees to at least five feet above ground level.					
Inspector Comment

View of the trees blocking visibility.

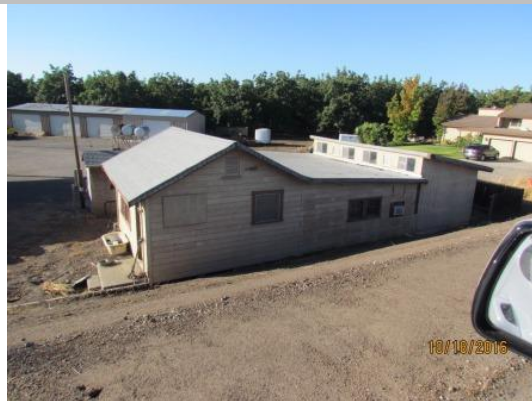
Photo 1 of 1 : FA_2016_RD0070_30_9_20161028_00111.jpg

LM Start	4.95	Rating **	U	Issue No.	9
LM End	4.98	Issue Type +	En	Location *	LS
Category	Earthen Levee			GPS Latitude/Longitude	
				Start	End
Item	Encroachments			39.142008 °	39.142032 °
				-121.926267 °	-121.926855 °
DWR ID	DWR_RD0070_02_s_2012_9				
Comment Code					
BU : Building					
Inspector Comment

View of a building within the easement of the levee.

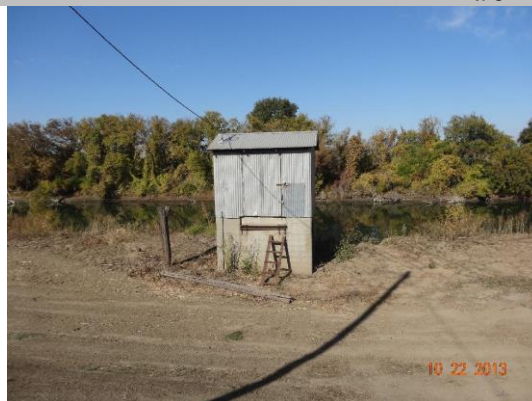
Photo 1 of 2 : UCIP_FA_2016_23964_42114.jpg

FS_ID:23964
DS_ID:21383
EP_NO: 9984
Repair Type: Non-Urgent
Crossing Status: Found
UCIP Comments: Will need to contact owner. Need to obtain maintenance records and clarify modifications made at to crossing (size). Additional crossing visible through concrete headwall on landward side--crossing has been capped (see photo). NEED TO CONFIRM PIPE SIZE!!! This crossing is referenced in the USACE Periodic Inspection as item USACE_CESPK_MRD2_2012_p_0289. FIELD_STRUCT_DESC: 12-inch (not 24-inch as mentioned in desk study) steel pipe through the levee, 13.8 feet below the crown. Gate valve on the waterward side. Pump in pump house on the waterward side. Concrete distribution box at the landward toe. (USACE-1953). This entry matches the Drainage or Irrigation Structure referenced in O&M manual (Station 555+09). This pipe was retained under ABO No. 9984 (1974).
FS Date: 10/22/2013

Pump house located on waterward side.

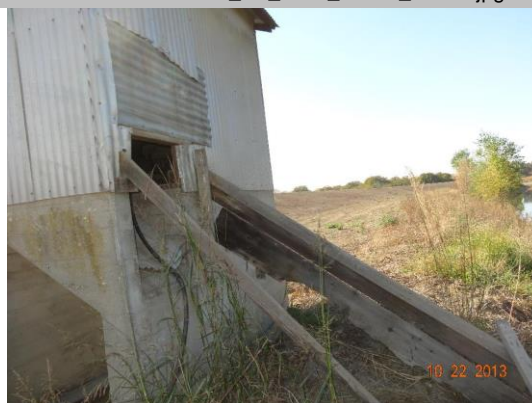
Photo 2 of 2 : UCIP_FA_2016_23964_42116.jpg

No pipe exists the pump house on waterward side.

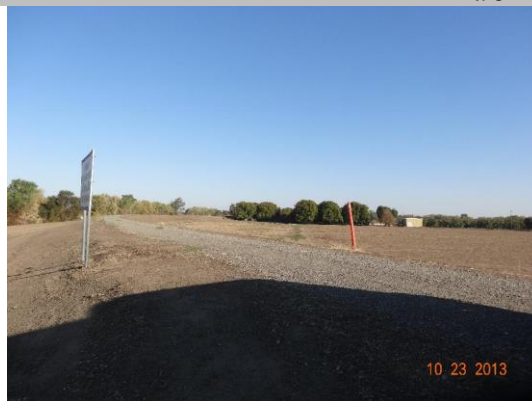
Photo 1 of 2 : UCIP_FA_2016_23965_42123.jpg

Comment Code					
Inspector Comment					
FS_ID:23965					
DS_ID:21385					
EP_NO: 4383					
Repair Type: Non-Urgent					
Crossing Status: Found					
UCIP Comments: Need to contact owner to determine if crossing is still active and to determine last inspection date. Will need copy of letter showing crossings passed inspection. This crossing is referenced in the USACE Periodic Inspection as item					
USACE_CESPK_MRD2_2012_p_0319.					
FIELD_STRUCT_DESC: 8 5/8-inch steel gas pipe through the levee, 3.5 feet below the crown. Concrete cutoff wall around pipe at center of levee. Rock revetment on waterward slope. (Permit No. 4383-1963)					
FS Date: 10/23/2013

Markers visible on both levee shoulders.

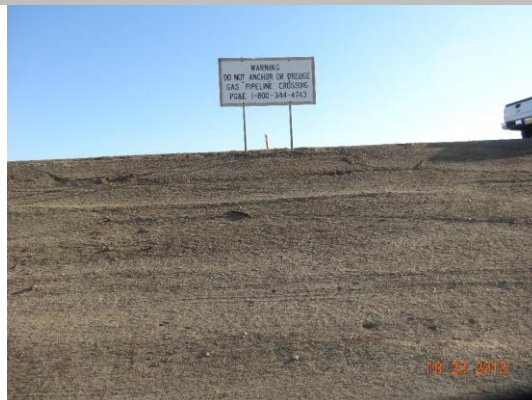
Photo 2 of 2 : UCIP_FA_2016_23965_42121.jpg

View of waterward slope.

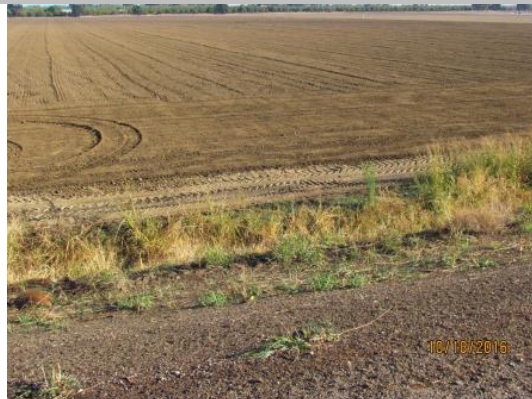
Photo 1 of 1 : FA_2016_RD0070_30_56_20161028_00112.jpg

LM Start	6.32	Rating **	U	Issue No.	56
LM End	7.09	Issue Type +	En	Location *	LS
Category	Earthen Levee			GPS Latitude/Longitude	
				Start	End
Item	Encroachments			39.133450 °	39.129024 °
				-121.937361 °	-121.924632 °
DWR ID	DWR_RD0070_02_f _ 2016_56				
Comment Code					
DT : Ditch					
Inspector Comment

View of a ditch at the landside toe.

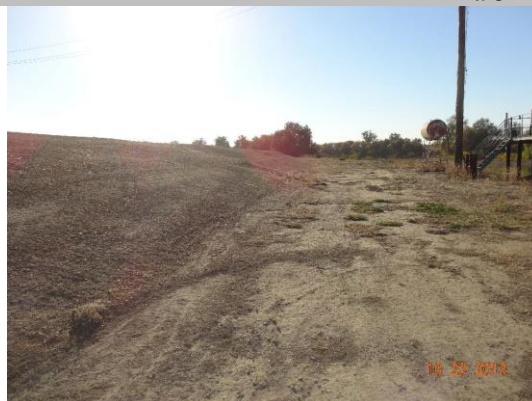
Photo 1 of 2 : UCIP_FA_2016_46424_42043.jpg

Comment Code					
Inspector Comment					
FS_ID:46424 DS_ID:21386 EP_NO: 9994 Repair Type: Non-Urgent Crossing Status: Found UCIP Comments: 07/28/2015 System was running during site visit. Damage to landward side has been repaired. No records available to determine cause of erosion--monitor. No other issues observed during site visit. 10/23/2013 Erosion visible on landward side behind concrete headwall. Plastic sheeting has been placed to protect slope. Need to determine cause for erosion, is pipe leaking? Pipe wall on landward side has deteriorated significantly that the wall is gone. Owner will need to coordinate with DWR inspector and CVFPB to address issue. Recommend notifying owner to stop using crossing until issue has been addressed. This crossing is referenced in the USACE Periodic Inspection as item USACE_CESPK_MRD2_2012_p_0324. FIELD_STRUCT_DESC: 20-inch steel pipe on waterward side and 24-inch steel pipe on landward side through the levee, 12.5 feet below the crown. Pipe is concrete encased under the crown, between the shoulders. Slide gate in metal well on waterward slope. Pump on pile structure in stream. Concrete discharge box at landward toe. Service pole on waterward slope. (USACE-1953). This entry matches the Drainage or Irrigation Structure referenced in O&M manual (Station 610+84). This pipe was retained under ABO No. 9994 (1974). This pipe was originally permitted in May 1, 1947 under Permit No. 1202. FS Date: 7/28/2015 3:46:00 PM

View of levee slope and berm on waterward side.

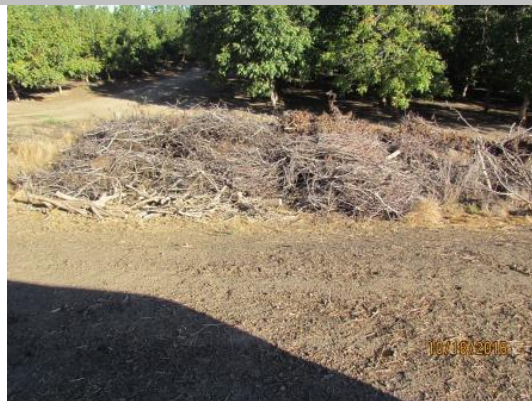
Photo 1 of 1 : FA_2016_RD0070_30_58_20161028_00114.jpg

LM Start	7.64	Rating **	U	Issue No.	58
LM End	7.64	Issue Type +	En	Location *	LS
Category	Earthen Levee			GPS Latitude/Longitude	
				Start	End
Item	Encroachments			39.124493 °	39.124493 °
				-121.917090 °	-121.917090 °
DWR ID	DWR_RD0070_02_f_2016_58				
Comment Code					
PR : Prunings					
Inspector Comment					
Remove prunings from the landside toe.

View of the prunings along the landside toe.

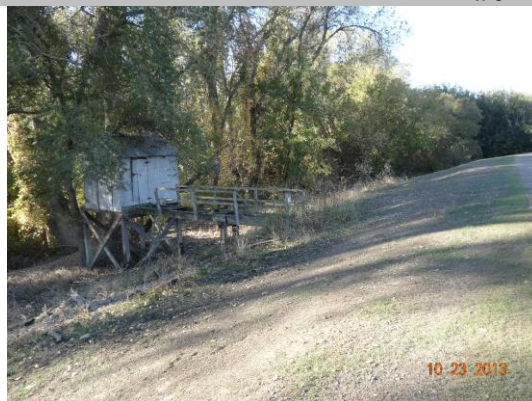
Photo 1 of 2 : UCIP_FA_2016_23966_42128.jpg

FS_ID:23966
DS_ID:21387
EP_NO: 9966
Repair Type: Non-Urgent
Crossing Status: Indicator Found
UCIP Comments: Pipe daylight at waterward side blocked. Unable to determine if connection is present--need to contact owner to determine if owner plans to use. If crossing is no longer in use owner will need to coordinate with DWR inspector and CVFPB to remove according to Title 23 requirements. Unable to determine if crossing is in use. This crossing is referenced in the USACE Periodic Inspection as item USACE_CESPK_MRD2_2012_p_0371.
FIELD_STRUCT_DESC: 10-inch steel pipe and 1.5-inch electrical conduit through the levee, 12.0 and 8.0 feet below the crown, respectively. Pipe is concrete encased under the crown, between the shoulders. Two concrete cutoff walls under each shoulder. Pump and gate valve on pile structure in stream. Walkway to pump. Concrete standpipe on the landward side. (USACE-1953). This entry matches the Drainage or Irrigation Structure referenced in O&M manual (Station 689+50). Pipe and conduit were retained under ABO No. 11496 (1975).

Pump house located on waterward side.

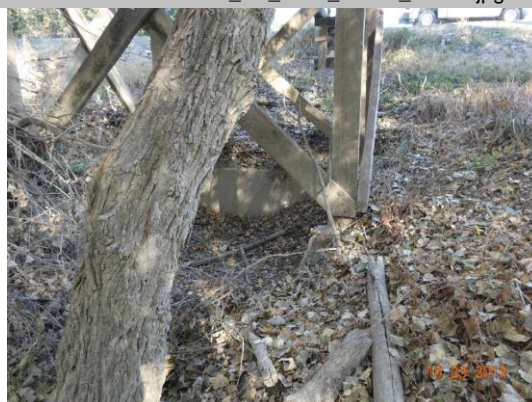
Photo 2 of 2 : UCIP_FA_2016_23966_42126.jpg

Concrete headwall located on waterward side.

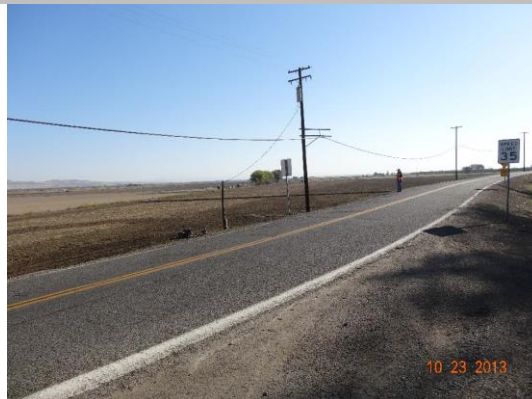
Photo 1 of 2 : UCIP_FA_2016_24191_42677.jpg

LM Start	7.92	Rating **	M	Issue No.	89
LM End	7.92	Issue Type +	En	Location *	LS
Category	Supplemental			GPS Latitude/Longitude	
				Start	End
Item	DWR UCIP Field Study			39.124543 °	39.124543 °
				-121.911996 °	-121.911996 °
DWR ID					
Comment Code					
Inspector Comment					
FS_ID:24191 DS_ID:21389 EP_NO: 1264 Repair Type: Non-Urgent Crossing Status: Indicator Found UCIP Comments: Need to coordinate with owner to determine status of crossing. If crossing is no longer in use owner will need to contact the CVFPB to comply with Title 23. This crossing is referenced in the USACE Periodic Inspection as item USACE_CESPK_MRD2_2012_p_0124. FIELD_STRUCT_DESC: Abandoned 10-inch (not 14-inch as specified in desk study) pipe through the levee, 5.0 feet below the crown. Pump on the waterward side. Double concrete discharge box at landward toe. (Permit No. 1264-1948) FS Date: 10/23/2013

View of levee crown at crossing.

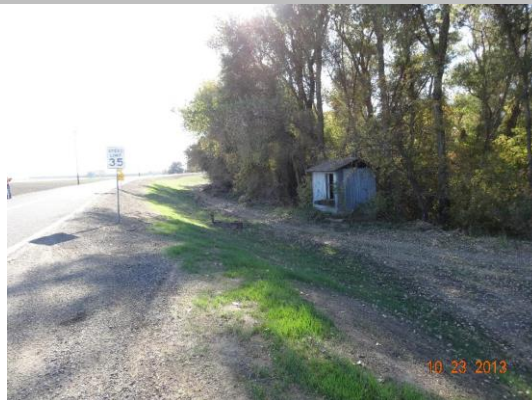
Photo 2 of 2 : UCIP_FA_2016_24191_42678.jpg

View of waterward side--only pump house of nearby crossing located downstream from crossing.

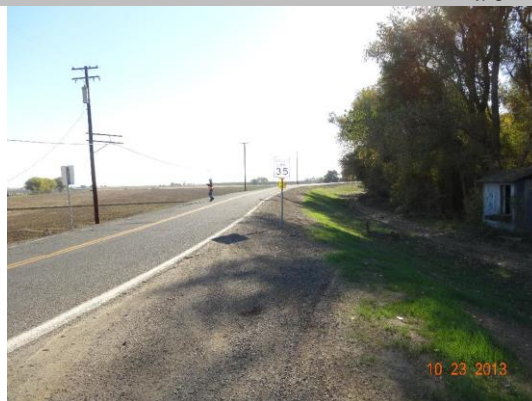
Photo 1 of 2 : UCIP_FA_2016_24190_42667.jpg

FS_ID:24190
DS_ID:21388
EP_NO: 10008
Repair Type: Non-Urgent
Crossing Status: Found
UCIP Comments: Concrete distribution box is damage on waterward side. Need to contact owner to determine status of crossing. If crossing is no longer in use owner will need to coordinate with DWR inspector and CVFPB to remove according to Title 23 requirements. This crossing is referenced in the USACE Periodic Inspection as item USACE_CESPK_MRD2_2012_p_0380.
FIELD_STRUCT_DESC: *ABANDONED* 18-inch steel pipe through the levee, 15.0 feet below the crown. Pump in pump house and slide gate on the waterward side. (USACE-1953). This entry matches the Drainage or Irrigation Structure referenced in O&M manual (Station 694+85). Concrete distribution box on landward side. This pipe was retained under ABO No. 10008 (1974). During field verification additional appurtenances were observed. An additional pipe on landward side drains into concrete distribution box. The concrete box connects to a second set of distribution boxes through a 24-inch concrete pipe approximately 36 feet upstream of crossing. Those boxes have a 10-inch pipe that appears to go through levee.

View of levee crown at crossing.
